# Industrial Pump Restoration

*“Equipment life and  
performance greatly improved*

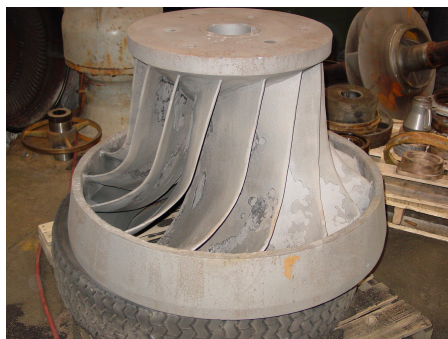
You give us this, and.....

Pumps are steel grit blasted to a 5-6 mill profile. The coating process involves three separate steps. First we concentrate on the deepest of the damage to the veins from the destructive forces of cavitation. Deep spots are pre-filled. Next, a coat of resin is applied to the surface of the rotor or pump cavity. Last, we apply second coat of repair material to the entire surface. Your impeller and pump body is now ready to put back into service. Many times less expensive than replacing your pump.

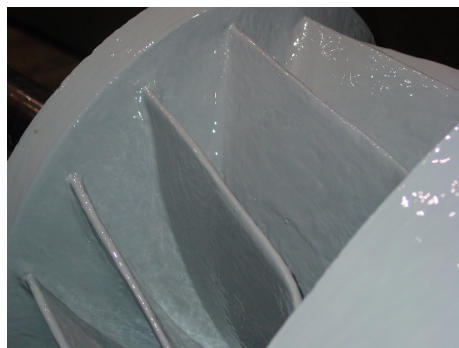
We bring it back like this!!
